Manhole Inspection Summary

Manhole # S15QQ_003MH

Insp Date: **3/24/09 1:52 PM**

Location Address: **2521 FOREST PARK AVE**

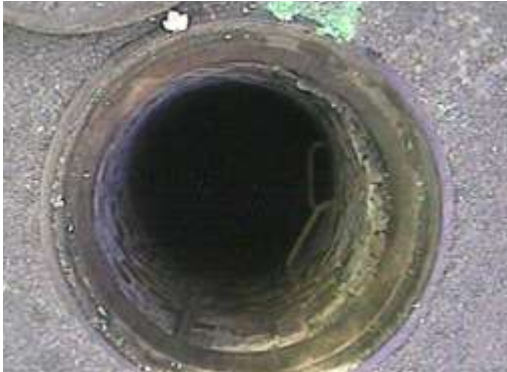
Top View

Offset: **2** (in.)

FRAME OFFSET

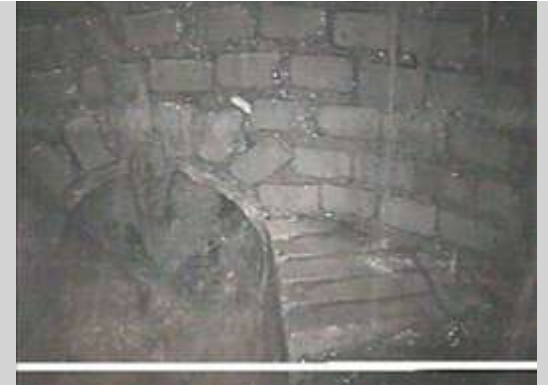
12 O'Clock Outflow

18 in. Circular Gravity Sewer
Pipe Out @ 12 O'Clock

Pipe Height: **14.4** (in.) Rod and Bar
Pipe Material: **Clay** ☐ Pipe Lined
Invert Depth: **16.93** (ft.) Flow Characteristics: **Fast**
Deposits: ☒ None ☐ Mud ☐ Sludge ☐ Debris ☐ Grease
Silt Depth: (in.) Deposits Extent:
Infiltration: **None** Pipe Seal Cond: **Sound**

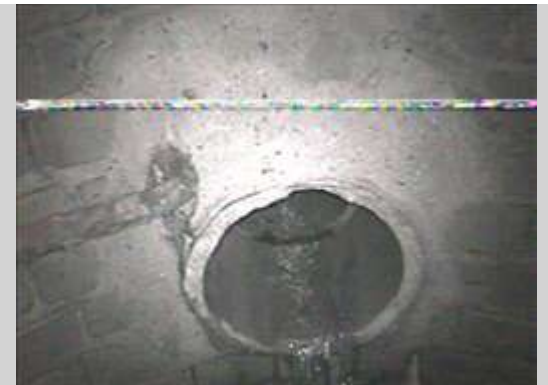
3 O'Clock Inflow

12 in. Circular Gravity Sewer
Pipe In @ 3 O'Clock

Pipe Height: **7.2** (in.) Rod and Bar
Pipe Material: **Clay** ☐ Pipe Lined
Invert Depth: **8.36** (ft.) Flow Characteristics: **Slow**
Deposits: ☐ None ☐ Mud ☒ Sludge ☒ Debris ☐ Grease
Silt Depth: **7** (in.) Deposits Extent: **Heavy**
Infiltration: **None** Pipe Seal Cond: **Sound**

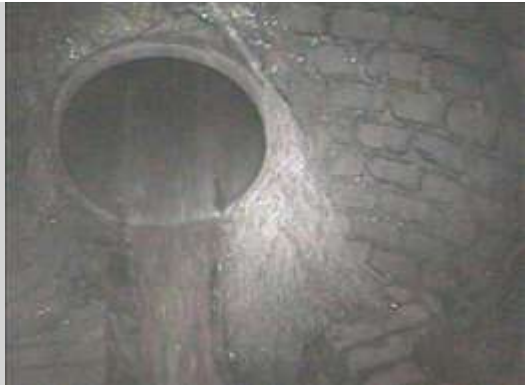
6 O'Clock Inflow

15 in. Circular Gravity Sewer

Pipe In @ 6 O'Clock

Pipe Height: 12 (in.) Rod and Bar

Invert Depth: 15.24 (ft.) Flow Characteristics: **Fast**

Deposits: ☒ None ☐ Mud ☐ ~~Sludge~~ ☐ **Debris** ☐ Grease

Infiltration: **None** Pipe Seal Cond: **Sound**

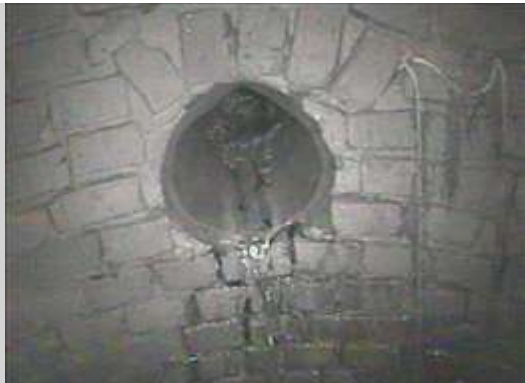
9 O'Clock Inflow

10 in. Circular Gravity Sewer

Pipe In @ 9 O'Clock

Pipe Height: 6 (in.) Rod and Bar

Invert Depth: 11.50 (ft.) Flow Characteristics: **Slow**

Deposits: ☐ None ☐ Mud ☒ ~~Sludge~~ ☒ **Debris** ☐ Grease

Silt Depth: 7 (in.) Deposits Extent: **Heavy**

Infiltration: **None** Pipe Seal Cond: **Sound**

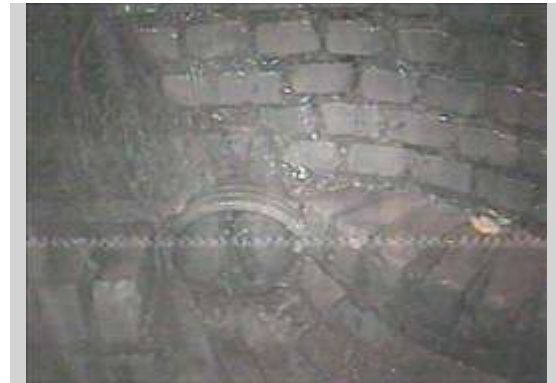
Drop In @ 9 O'Clock

Drop: **Outside Direct**

Inv Depth: 16.25 (ft.)

Drop Condition: **Open**
